# FLATIRONS EVENT CENTER

## ASSESSMENT OF EXISTING BUILDING

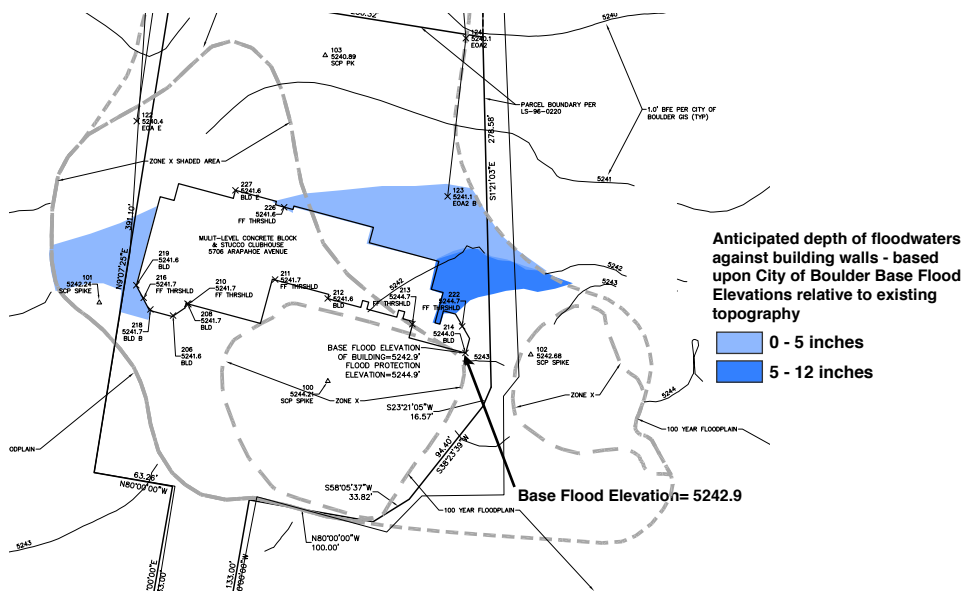
The following Diagram 2 shows a simplified analysis of flood depths relative to grade/building elevations. The greatest depth of water against the structure is likely to occur on the east side of the structure where water may be as deep as 12 inches. Lesser depths of water against the structure are possible along the eastern portion of the north elevation. Although the west side of the structure is outside the 100 year flood zone on the maps a closer analysis of grades adjacent to the structure and anticipated BFE indicates that there is a possibility of up to 5 inches of water against the wall at on the west side of the ballroom space.

*Flood Diagram 2 - floodwater depth against building walls*

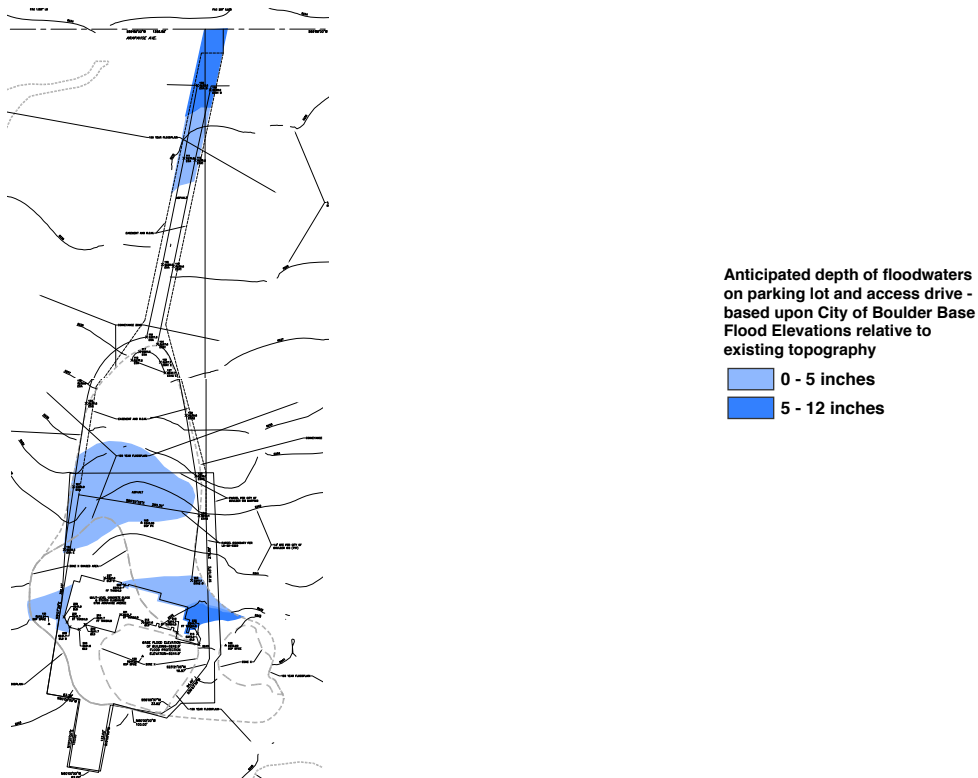
Diagram 3 shows that a portion of the parking area may be between 0 and 5 inches below the flood water elevation in a 100 year event. The northern portion of the access road may also be beneath the surface of floodwaters in a 100 year event. Depths vary between 0 and 12 inches with depth increasing as the access road approaches Arapahoe Avenue. This portion of the access road is within the conveyance zone.

Flood Diagram 3 showing floodwater depths on parking lot and access drive.

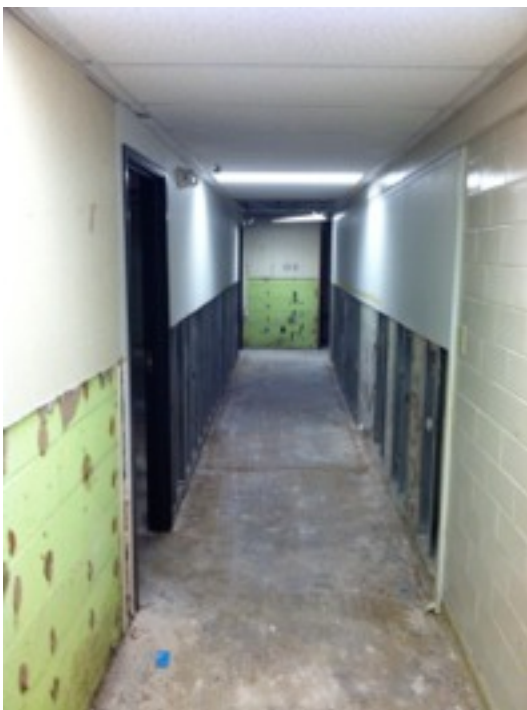
Wood and metal framed interior partition walls sustained some damage during the flood event of September 2013. This was most commonly from flood water absorbed by gypsum wallboard. The majority of the walls that have been damaged have been "flood cut." Drywall material has been cut either 2'-0" or 4'-0" above the floor and removed to allow interior wall cavities to dry out.

*Flood cut gypsum wallboard on interior partition framing. Floor finishes removed.*

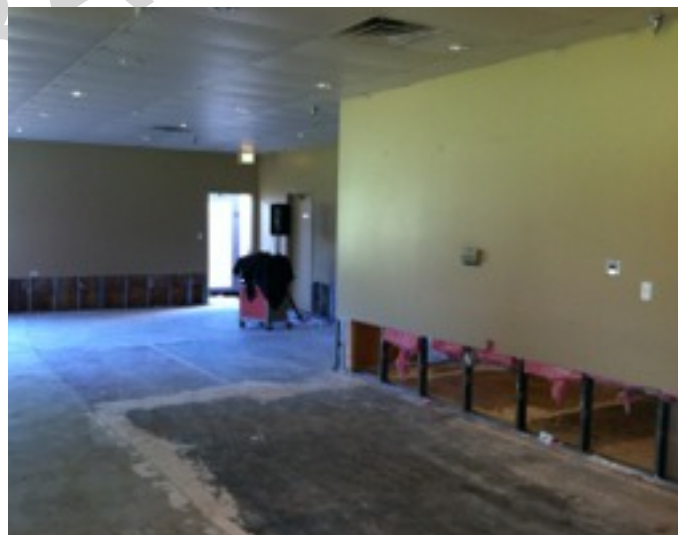
*Flood cut interior partition and exterior wall in western portion of the structure.*

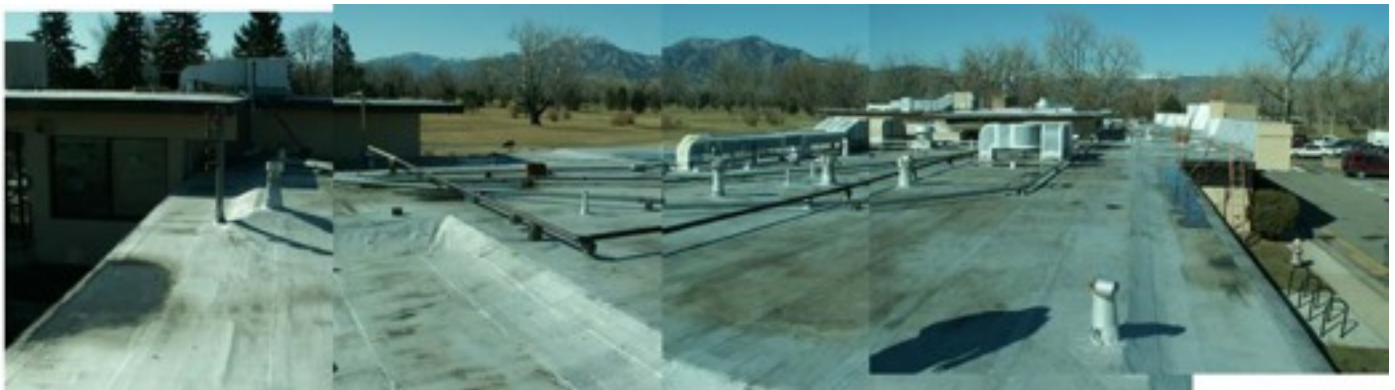
The roof membrane is extremely compromised in many locations from poor design and detailing, years of inadequate maintenance, continual soaking due to water penetration and repeated application of new membranes over older systems.

*Overall view of roof systems from northeast corner of building - 2008.*

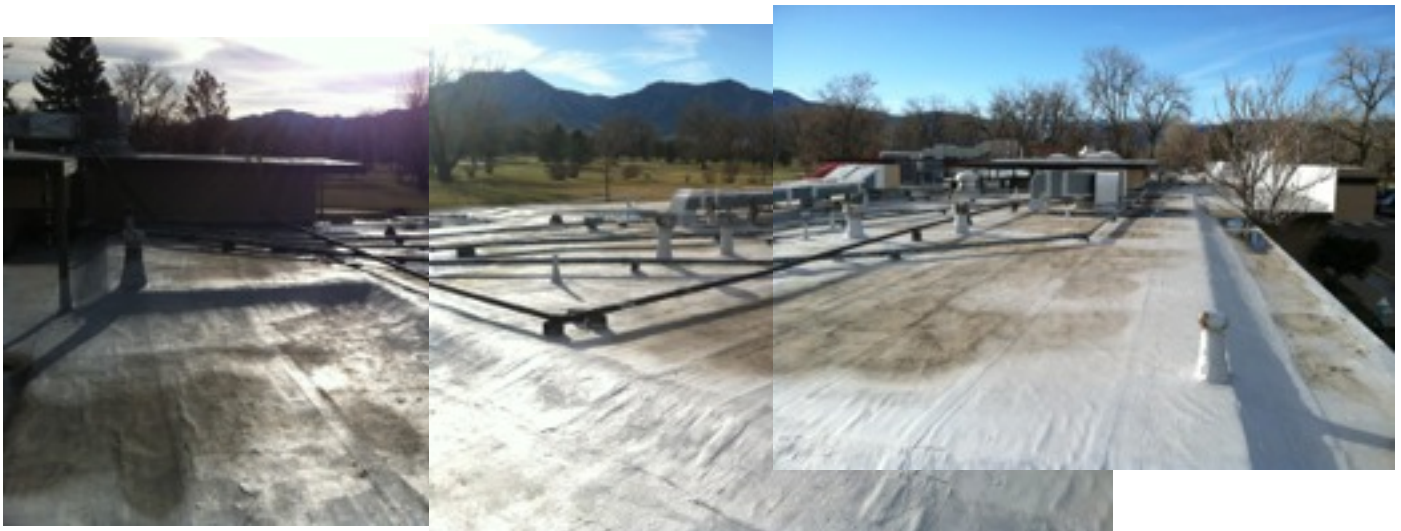
*Overall view of roof systems from northeast corner of building - 2013.*

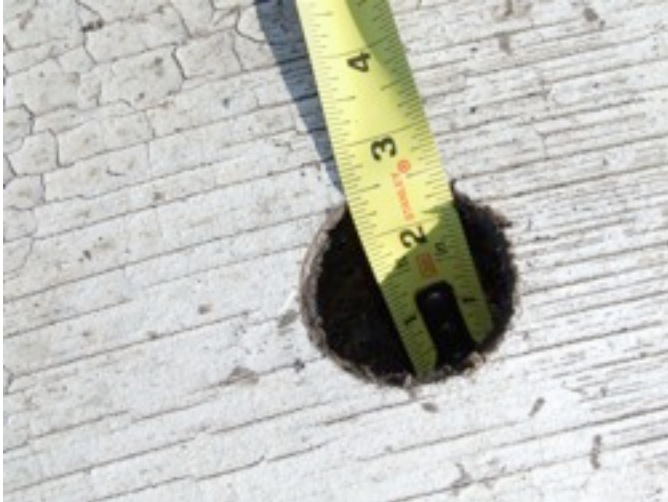
Test core hole in existing roof - 2008.

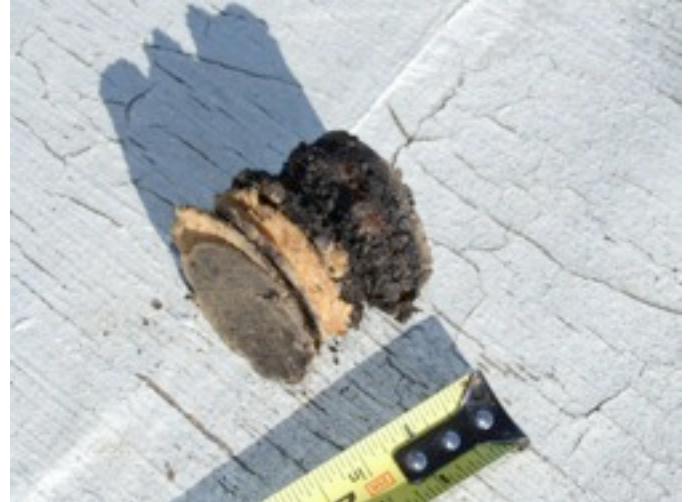
Test core sample taken from roof - 2008.

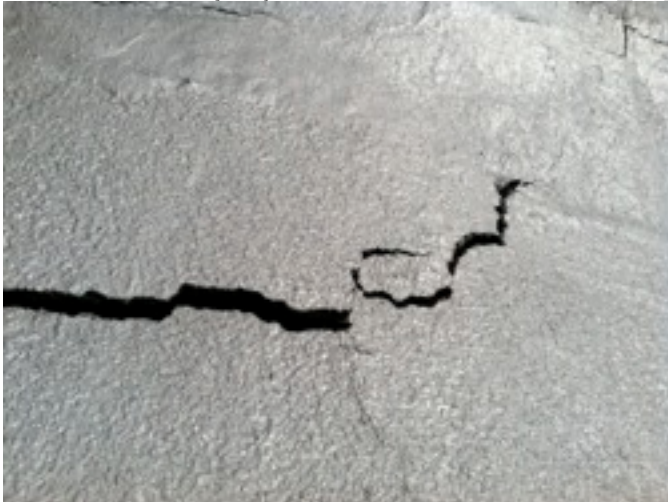
The roof membrane currently exhibits many signs of stress. Fissures in the membrane are commonplace particularly where flat roof surfaces are flashed onto parapets or other vertical surfaces. Management has stated that roof leaks continue to be systemic. Fissures in the membrane may be just one location for water infiltration.

Fissure in surface of the roofing membrane

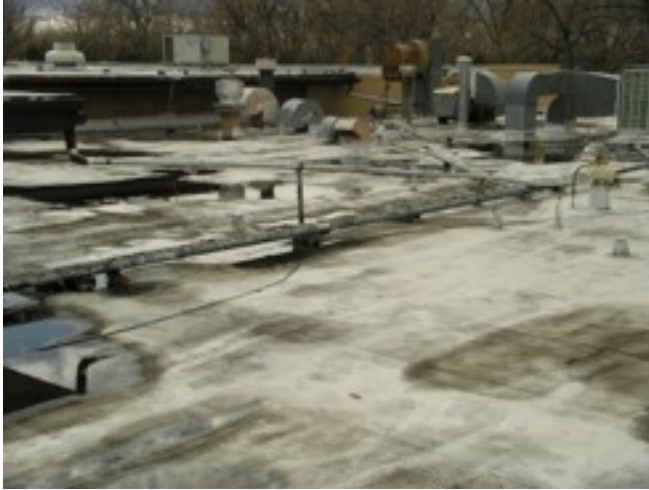
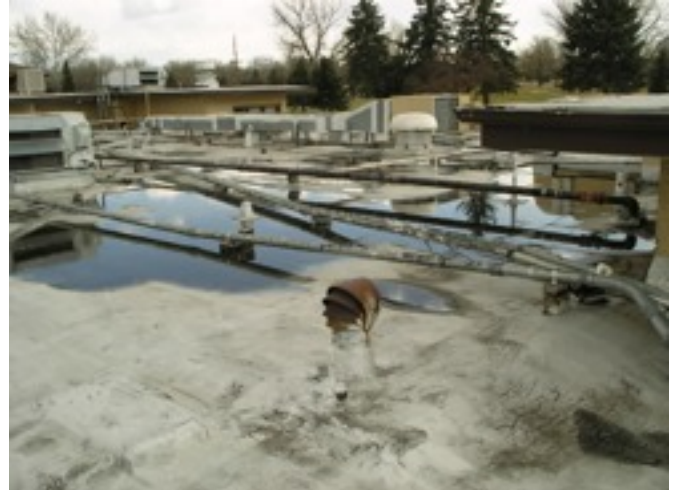
There is little positive drainage on large portions of the roof. Water ponds on the surface in many locations. At the time of one previous observation, within two days of a snowfall, approximately one half of the roof was beneath standing water. In some locations the water was several inches deep. These problems are particularly acute over the older portions of the building. Many of the areas of most significant water damage on the interior occur beneath these areas of ponding. Any replacement of the roofing system must include a complete reworking to create positive slope to drains or gutters.

*Water ponding on roof in 2008.*

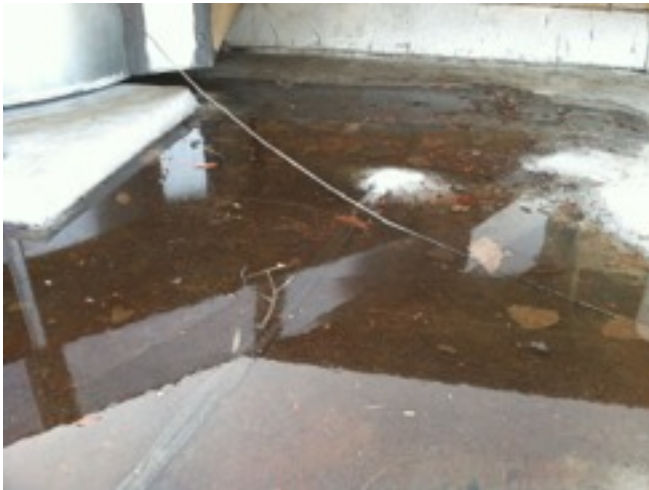
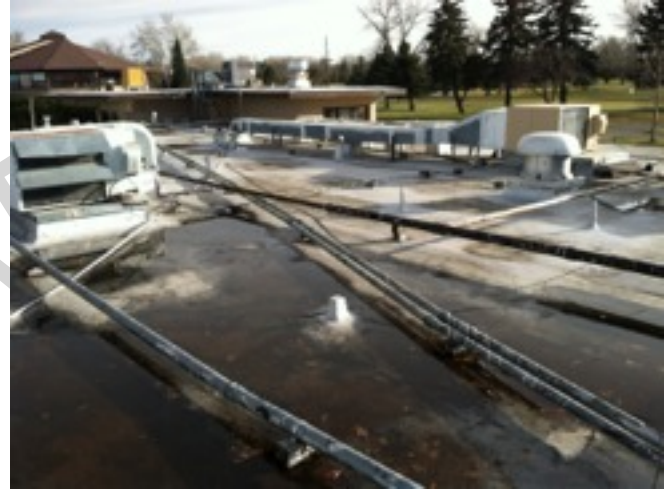
*Water ponding on roof in 2013.*

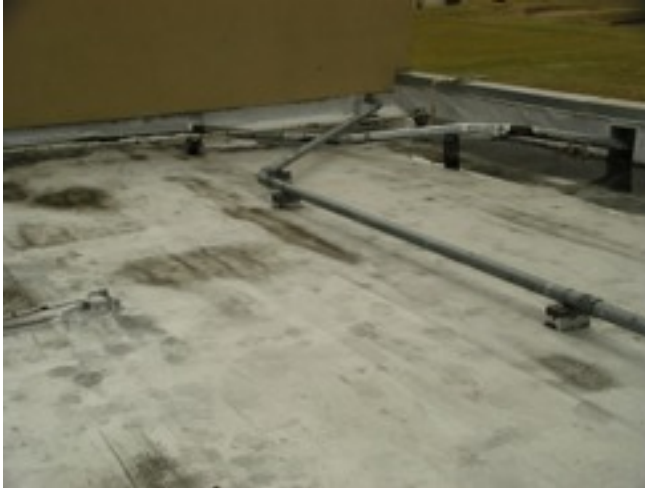
The roof is intended to drain to internal drains in some locations and over the edge of the roof into external gutters in others. There is little logic to the system. There are a number of locations where the water collected in gutters is run through downspouts to roof drains and others where water collected in downspouts is run to other lower gutters or collector heads. In many instances the downspouts run flat on the lower roof surface or even up and down through other equipment and utilities arrayed across the roof. Currently most of the downspouts are damaged, crushed and/or separated at joints. The joints between adjacent sections of downspout are taped with aluminum (non-watertight) tape.

*Downspout from upper roof run across lower roof in 2008.*

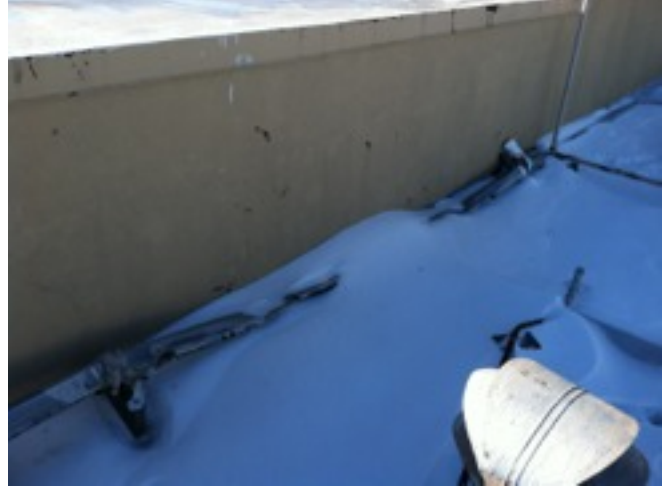
*Condition of downspouts from upper roof - 2103.*

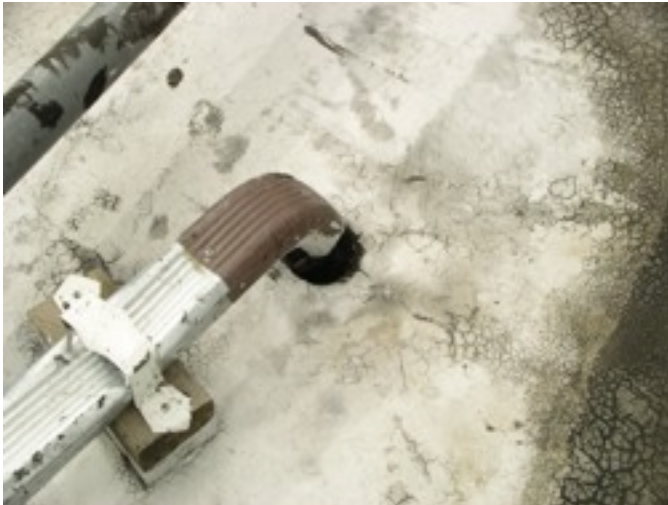
Roof drains over the older portions of the building do not have proper drain bodies or debris screens. In several locations the roof drains appear simply as a hole in the membrane. None of the roof drains has an accompanying overflow drain in the event of blockage of the primary drain.

*Downspout from upper roof discharging into roof drain on lower roof. The drain is almost unrecognizable as multiple layers of re-roofing has covered over the drain body and intake. This condition remains unchanged in 2013*

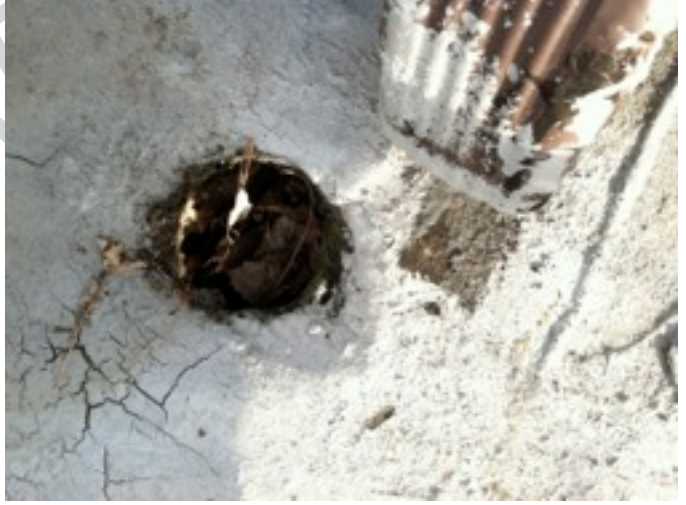
*Downspout discharging above roof drain (hole in roof membrane). Note the drain opening is clogged with leaf litter and debris likely causing water intrusion and leakage. 2013.*

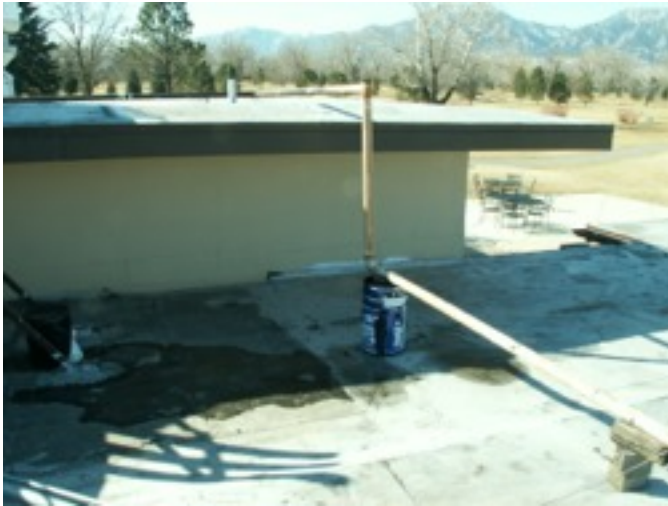
supported for a considerable length by resting directly on other piping or conduit. This is a code violation. The majority of the electrical conduit and mechanical piping running across the roof is supported on wood blocks resting on the roof membrane. These support points are not anchored to the structure, allowing the supported conduit or piping to be moved. This can cause mechanical joints in the conduit or piping to open and allow water penetration. In many locations the conduit or piping is not secured to the wood block and in several the wood block is secured to the pipe or conduit but is suspended above the roof surface. In some instances the wood blocks have deteriorated to such an extent they are beginning to crumble.

*Gas supply piping run over roof surface supported on discarded roofing material bucket - 2008.*

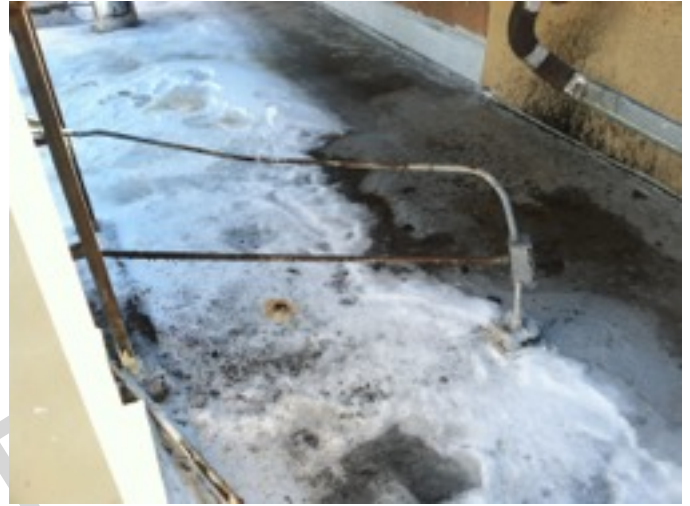
*Unsupported electrical conduit - 2013.*

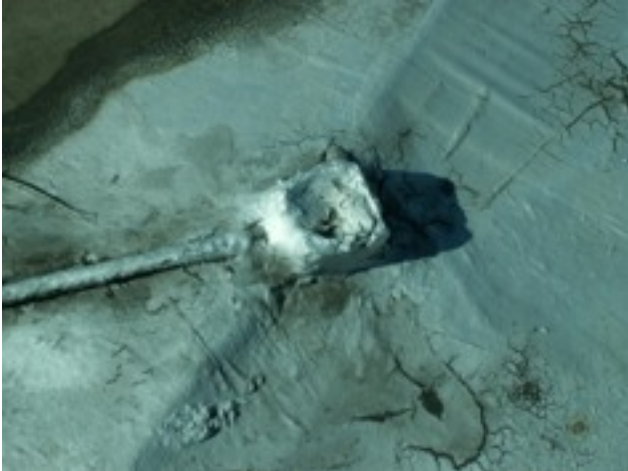
3. Horizontal penetrations. All elements should pass through the roof surface in a vertical direction to allow flashing and counterflashing of the penetration. Several conditions of elements penetrating the roof in a horizontal or near horizontal fashion were observed. These penetrations can never be adequately waterproofed.

*Unable to discern whether this is an electrical junction box or a pitch pocket. The electrical conduit leaving the box is impossible to make watertight.*

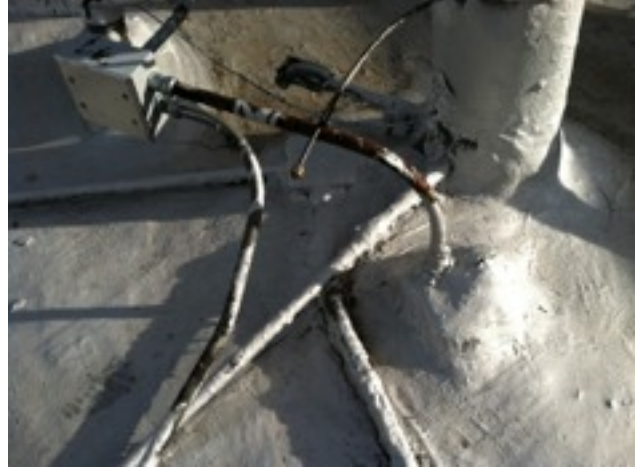
*Multiple roof penetrations with no discernable flashing.*

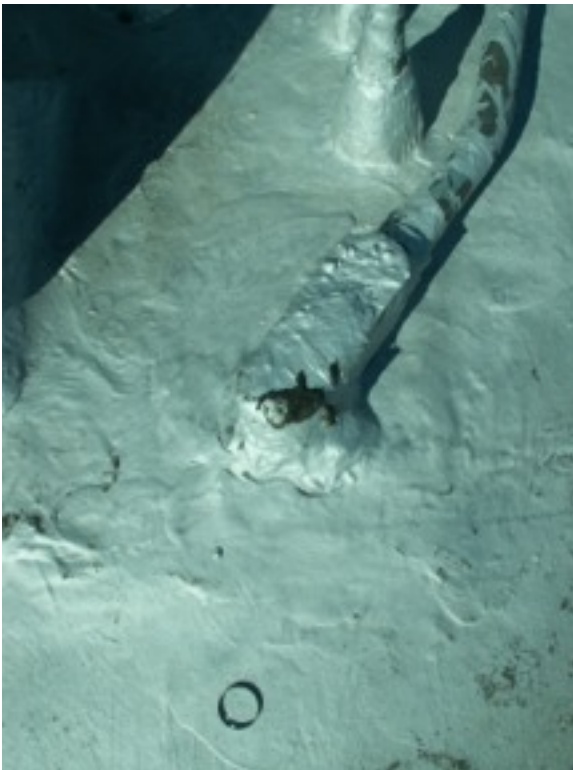
*Electrical junction box at roof surface creates a crevice beneath it that is impossible to make permanently watertight.*

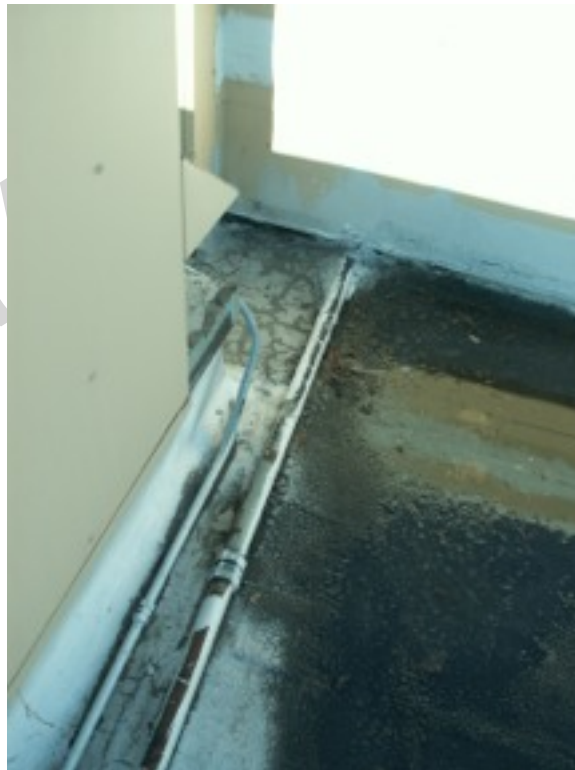
*Electrical conduit exiting horizontally beneath mechanical equipment*

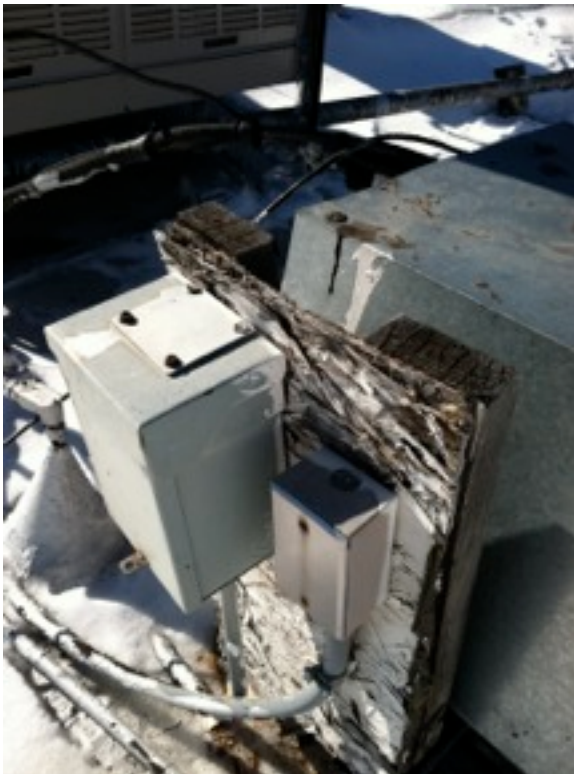
*Electrical service disconnect switch mounted on deteriorated oriented strand board panel. It appears that the electrical service is supporting the board at this point in time rather than vice versa. 2013.*

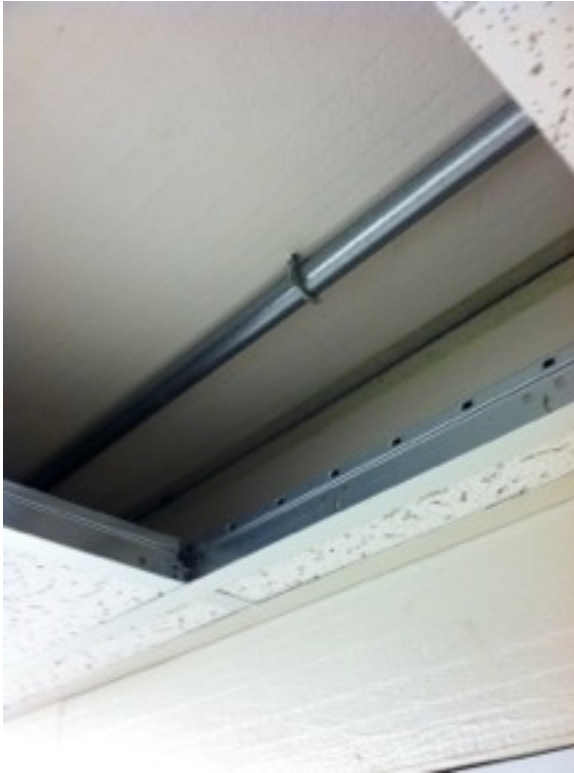
Alarmingly it appears that continued alteration to the structure has resulted in striking, impaling and drilling of the transite panels in at least two locations in the eastern portion of the building. In the former mens' locker room new fire protection piping has been installed. Anchors for this suspended piping have been drilled or impaled into the Transite panels. In the former womens' locker room a new corridor has been created through the space. New light gauge metal framing, electrical conduit and suspended ceiling grid have been screwed, nailed or pinned to the Transite panels. It is likely that these actions released asbestos fibers into the air. It is highly recommended that this asbestos containing material be removed from the structure to prevent further health risk.

*New suspended ceiling grid and electrical conduit attached to Transite panels containing highly friable asbestos. This scope of work has been completed since the 2008 assessment.*

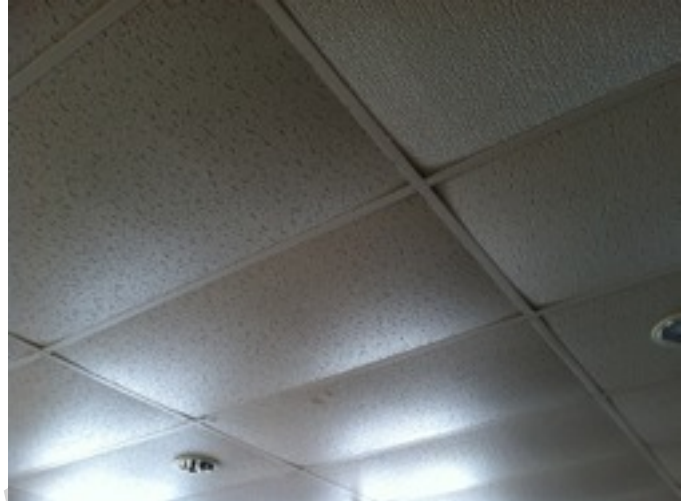
*Ceiling panels within ballroom space - 2013.*

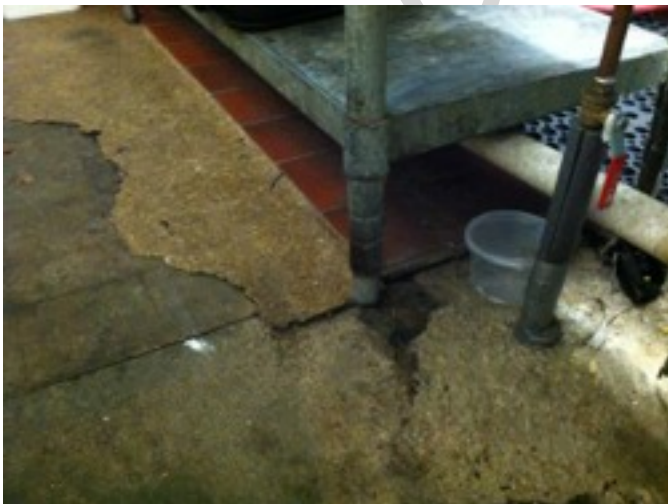
Removal of carpet has revealed that a large portion of the original flooring throughout the entire pre-1980 portion of the building are 9x9 tiles containing asbestos. 9x9 tiles exist in the following spaces: east side of the ballroom, ancillary spaces north of the east side of the ballroom, hall between ballroom and kitchen spaces, lounge space, old mens' locker room. The environmental report of 2008 listed approximately 350 s.f. of asbestos containing floor tile. We currently believe the approximate area of the asbestos containing floor tiles to be in excess of 4000 s.f. The removal of the glue down carpet has cracked and broken the older floor tiles in a number of areas. Although the asbestos within these flooring tiles is considered to be generally non-friable there is a small chance that the removal of the carpet released a small amount of asbestos fiber into the atmosphere. Areas with broken and fractured tile include: the storage space to the north of the corridor between the kitchen and the entry, the perimeter of the east side of the ballroom. It is recommended that all loose, cracked and broken 9x9 tile be properly abated immediately to reduce further potential exposure to asbestos fibers.

*Asbestos containing sheet flooring in kitchen spaces. Continued deterioration along edged between 2008 and 2013.*

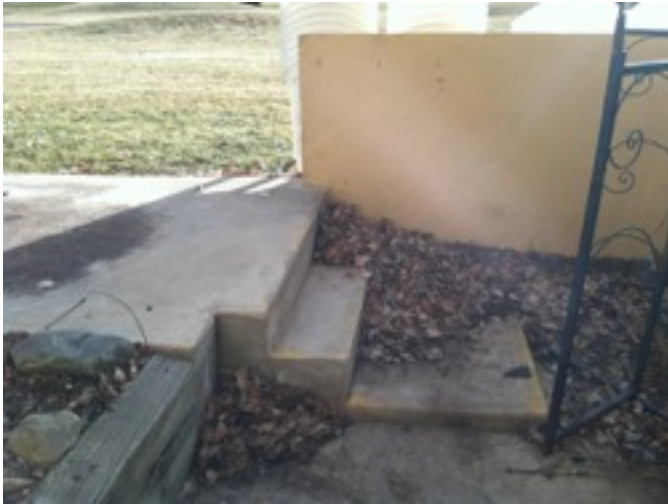
wall. Previously this exit did not have any at-grade egress without climbing over the landscape timber wall. A new concrete stair has been constructed but the stair dimensions are not code compliant. The depth of the landing at the bottom of the stair is deficient and the landing is not at grade but approximately two inches above it. The landing depth must be a minimum of 44" in the direction of travel. The two inch vertical dimension of the step onto the landing is less than the 4" minimum for a step. A sloped concrete surface (ramp) should make the transition from grade to the landing elevation. In addition, the stair does not have its required handrail.

*Non-compliant stair to grade outside south door in ballroom. Depth of landing at bottom of stair too shallow. 2" offset between landing and concrete flatwork path at interior floor elevation. No handrail.*

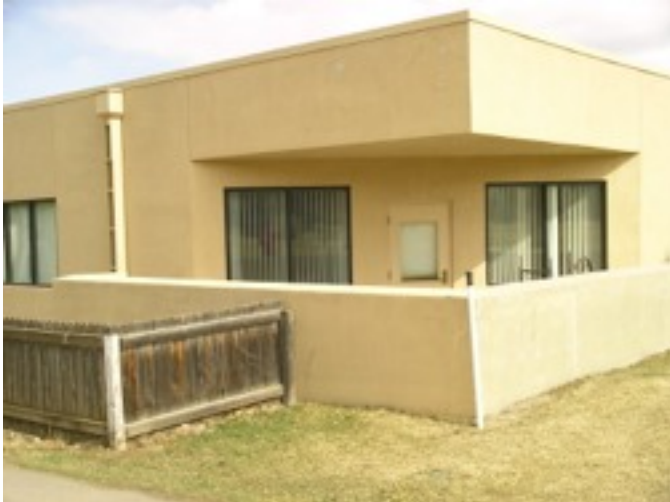
*Southwest exit door behind site wall blocking path to public way.*

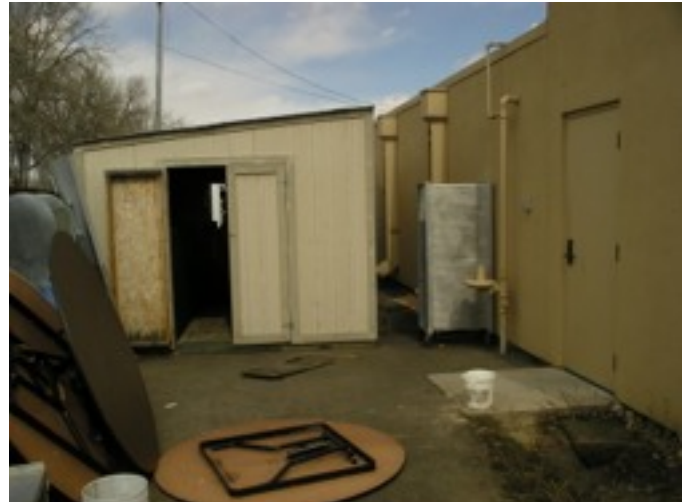
*West exit door opens onto space enclosed by fence and accessory structure, egress path obstructed by equipment stored in space between building and accessory structure.*

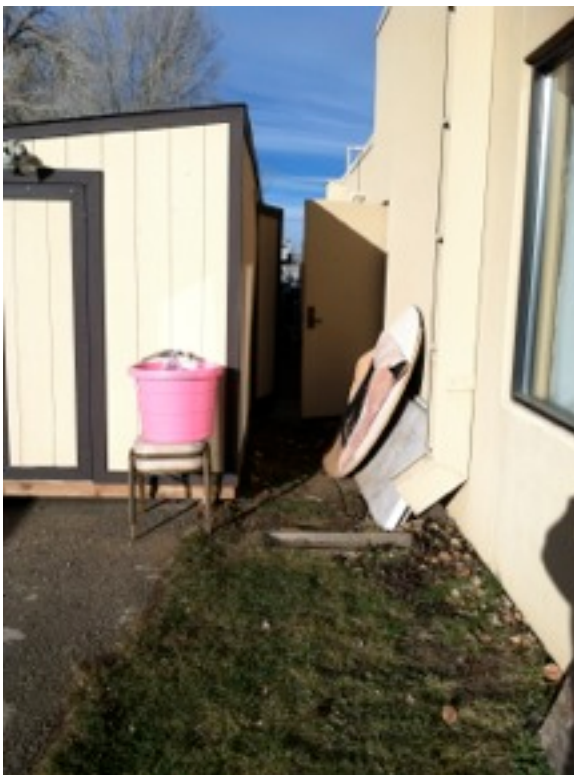
*Accessory structure has been moved farther to the south between 2008 and 2013. The structure now blocks the egress path from the west exit door. Equipment and materials stored between Event Center and accessory structure obstruct egress width. 2013.*

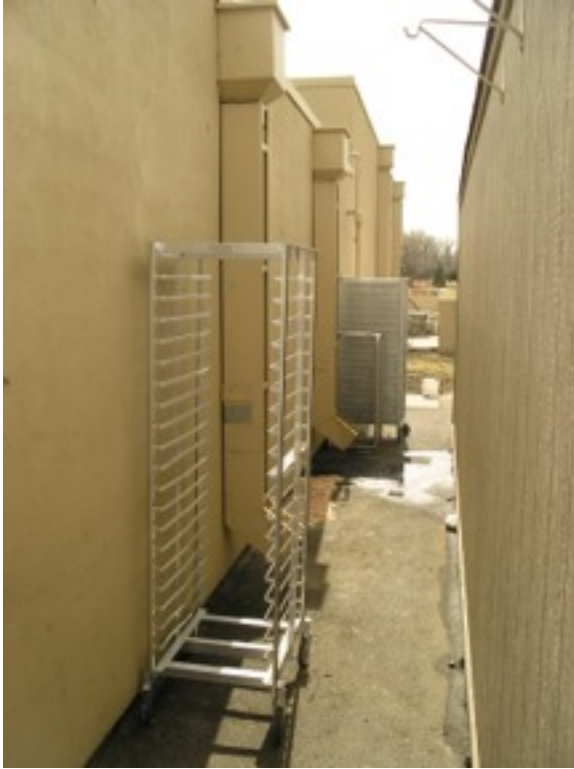
*Narrow egress path from southwest and west exit doors constrained by building wall and accessory structure, path obstructed by equipment stored by building tenant. 2008.*

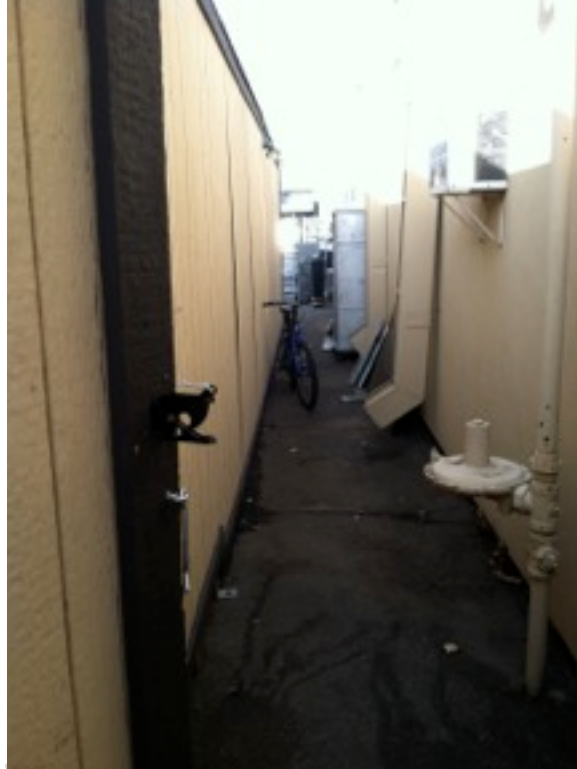
*Egress path between Event Center and accessory structure obstructed by food carts bicycle and other items. 2013.*

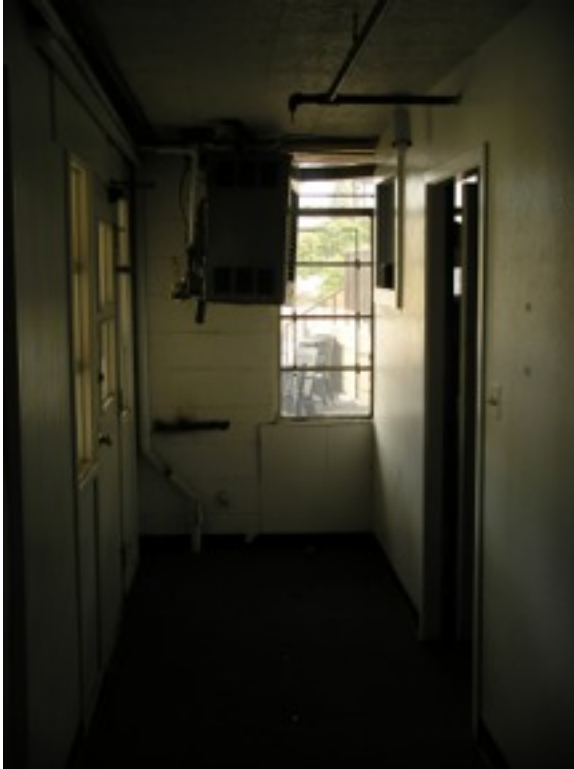
This exit path and exit door are compromised by a unit heater suspended from the ceiling of the corridor immediately adjacent to the exit door. The unit heater is supplied with natural gas via exposed piping within the exit corridor. This heater and its fuel supply are an extreme hazard to occupants needing to exit from the structure.

*Gas-fired unit heater installed within exit corridor serving the east side of the building.*

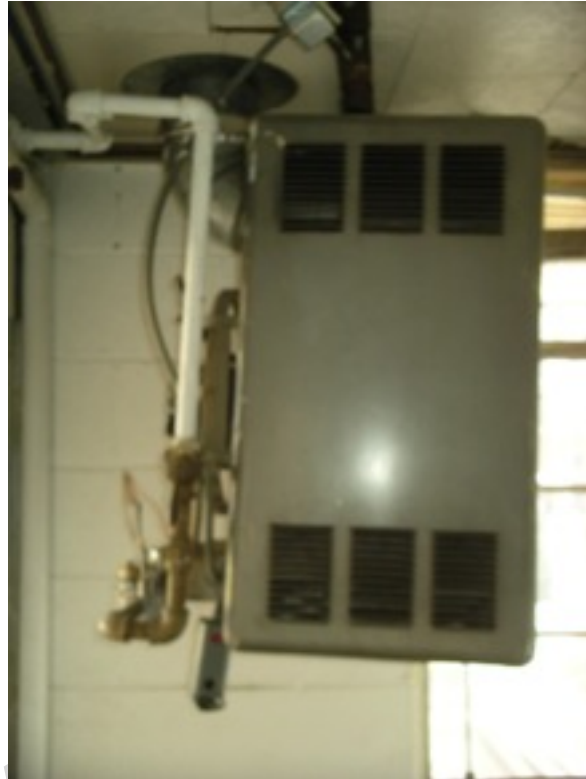
*Gas-fired unit heater.*

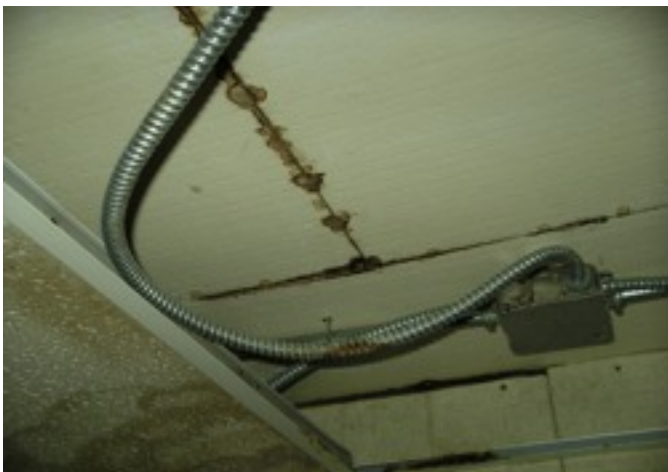
Failure to properly abate known asbestos containing material opens the owner to future liability in the event of exposure of occupants of the building.

*Transite ceiling panels are found throughout the eastern portion of the building. This is an asbestos containing material. Cutting, drilling or striking the material as was required for installation of the visible electrical system elements can result in the dispersal of asbestos fibers into the atmosphere. Note the signs of water migration through the material at panel joints. Also note the signs of corrosion on the metal electrical conduit and junction box.*

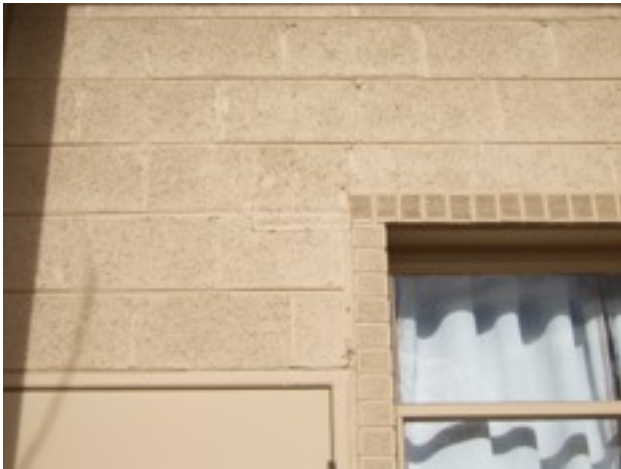
The comparative graphs shown in Figure 3 generally show fairly minor differences between the elevations measured in 2008 and those measured in 2013. However, there is one notable exception. The measurement at the southwest corner of the building is about 0.4" higher in 2013 than measured in 2008. There is also some significant cracking in the exterior finishes and distress at interior finishes in this area that were not observed in 2008, as shown in Figure 4 through Figure 7.

Figure 4. View of stair step cracking in exterior concrete block wall near door and window corners at southwest portion of building. Red dashed line indicates crack location.

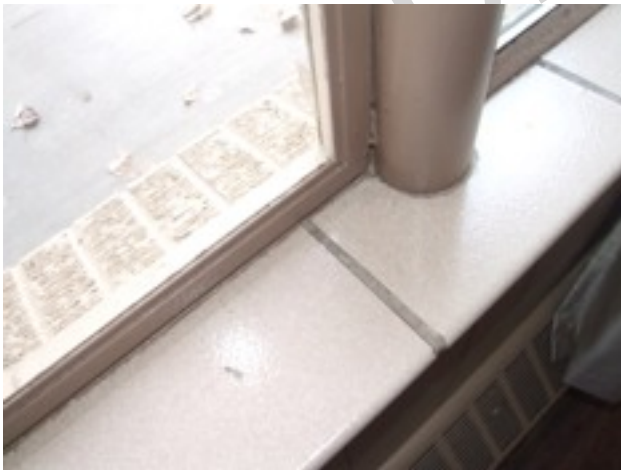
Figure 5. View of cracking and displacement at both interior and exterior finishes at a window sill in the southwest portion of the building. Crack location indicated with arrows.

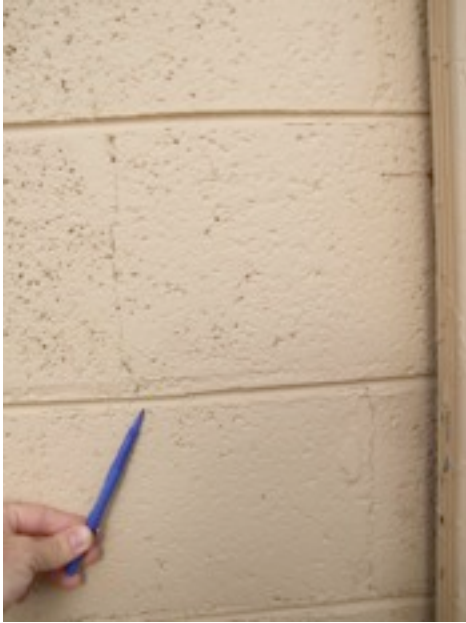
Figure 6. View of stair step cracking in exterior concrete block wall at southwest portion of building.

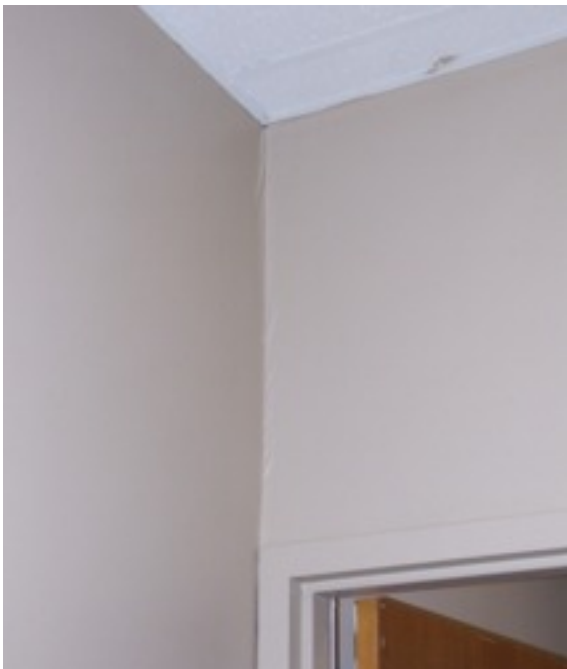
Figure 7. View of wrinkles and cracks at interior paint in corner at southwest portion of building.

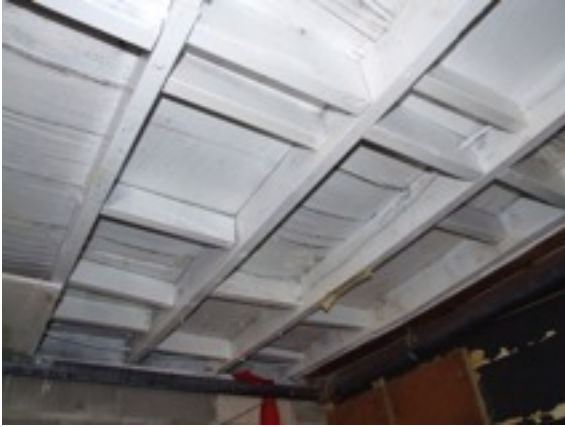
Figure 9. View of plywood roof decking and wood framing at the east end of the building, showing moisture effects on the plywood. Note that the interior surface has been painted white.
